TESTS OF EFFECTS OF LONG DURATION BLAST-TYPE FLOWS ON FIRES IN
INTERIORS (INCLUDING EOC'S)

INTERIM TESTS OF THE EFFECTS OF LONG DURATION BLAST-TYPE FLOWS ON FIRES IN URBAN INTERIORS AND ON THE CONTENTS OF EMERGENCY OPERATING CENTERS (EOC)

C. Wilton
R. Kaplan
SCIENTIFIC SERVICE, INC.
1536 Maple Street
Redwood City, California 94063

Contract No. DAHC20-73-C-0195
DCPA Work Unit 2563A
COTR - Dr. Michael A. Pachuta

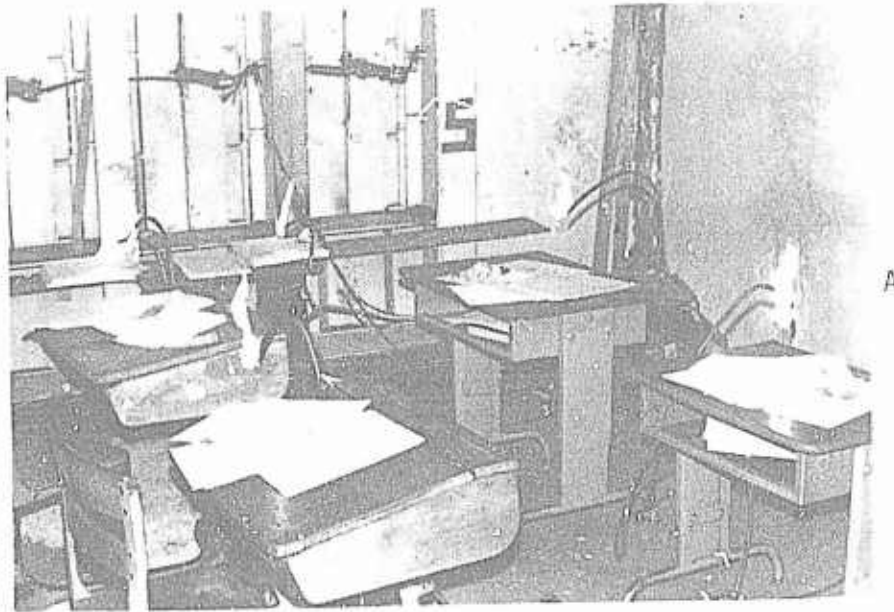
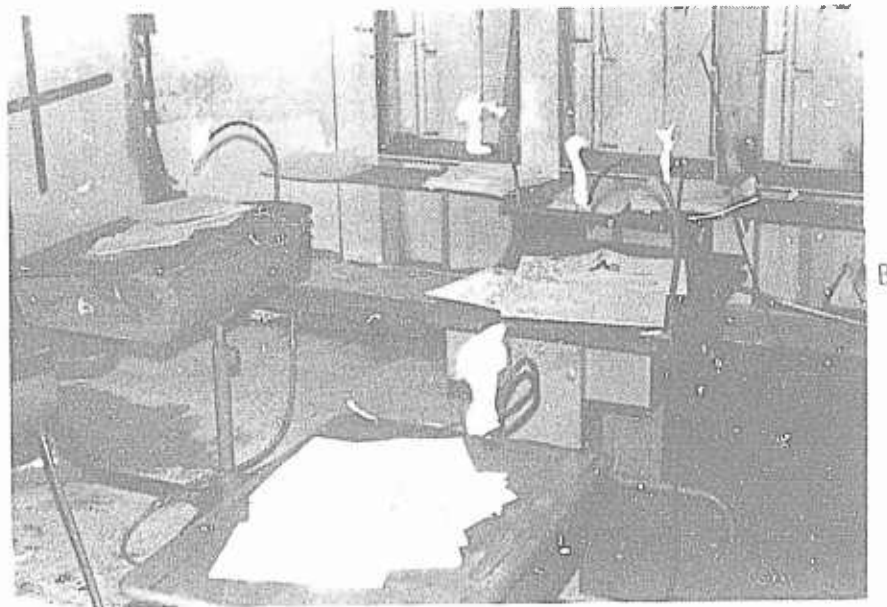
Fig. 3-6. Pretest Photographs, Test Number 5.

Two tests (Numbers 5 and 12) were conducted with geometries similar to that shown in Fig. 3-5. Before the tests, papers were scattered about on the four desks, and an open book was placed on the window sill, as shown in Fig. 3-6. The ignition sources also shown in Fig. 3-6 were used to ignite the papers.

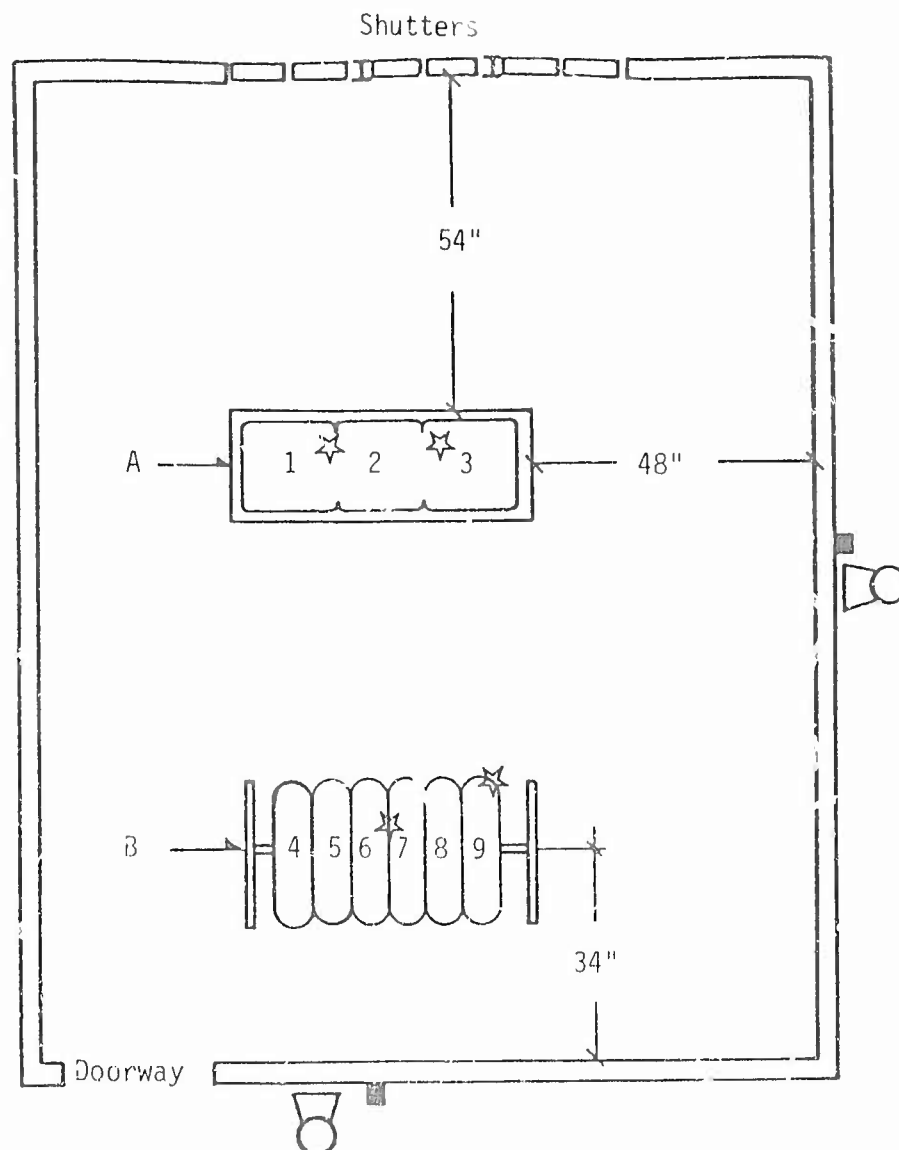
Fig. 3-8. Sketch of Test Geometry, Test Number 15

- A - 5- x 18 in. table
- B - 49 in. long, 60 in. high clothes rack
- 1 - terry cloth
- 2 - denim
- 3 - mixed duck and muslin
- 4, 7, & 8 - muslin
- 5, 6, & 9 - duck
- ☆ Ignition sources

and burst into flame after some 10 minutes had elapsed. After both 4 psi and 6 psi chamber pressure tests both flames and smouldering combustion were extinguished in the pieces of cloth that were ejected from the room (which constituted most of those that were originally in the simulated stores). In each case, however, one still smouldering piece was deposited directly beneath the window opening where after about five minutes it burst into flame.

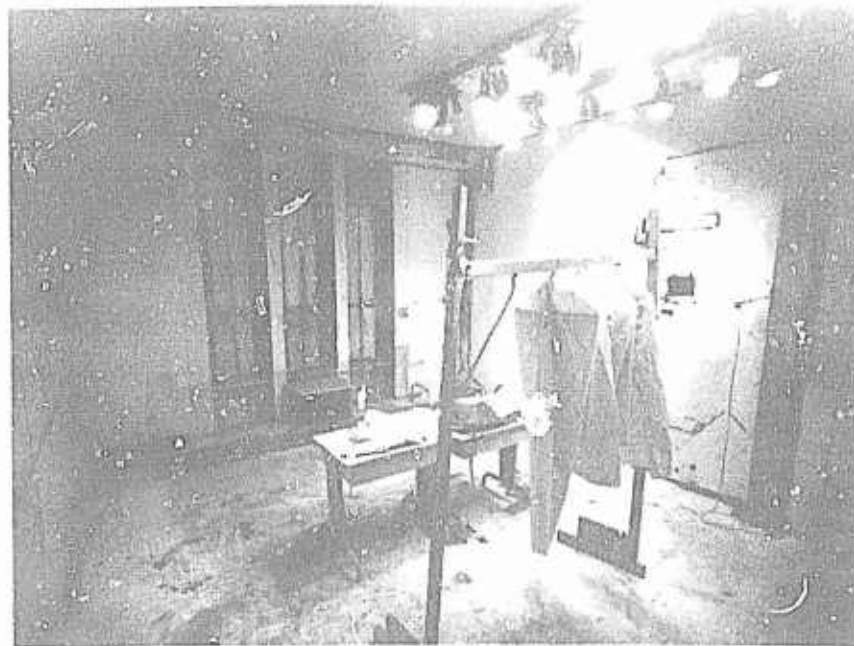
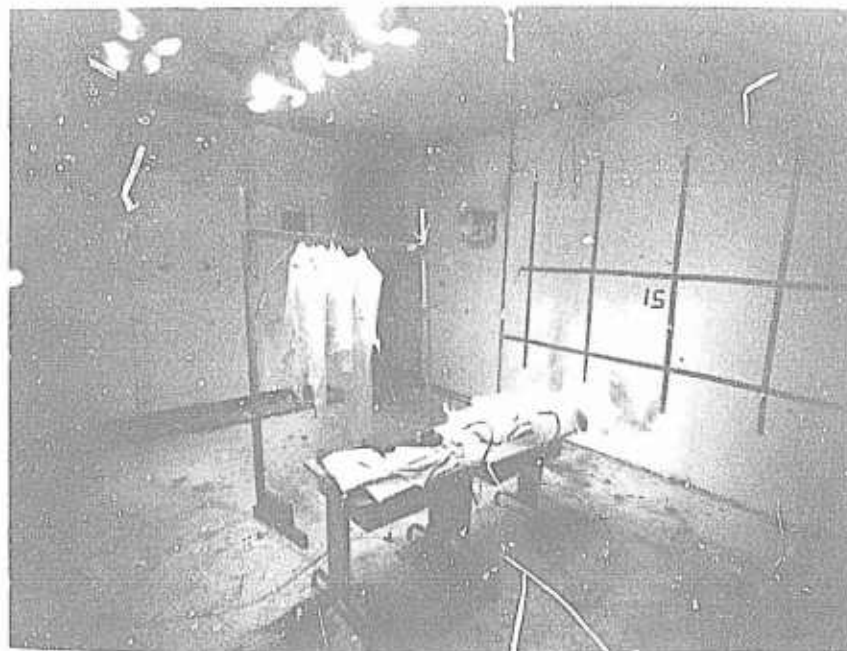
Fig. 3-9. Pretest Photographs, Test Number 15.

Three tests (Numbers 6, 11, and 15) were conducted with geometries similar to that shown in Fig. 3-8. Folded pieces of terry cloth, muslin, denim, and duck were placed on a table upstream from a clothing rack from which pieces of similar cloth were hung. Overall views of one of the simulated stores are shown in Fig. 3-9.

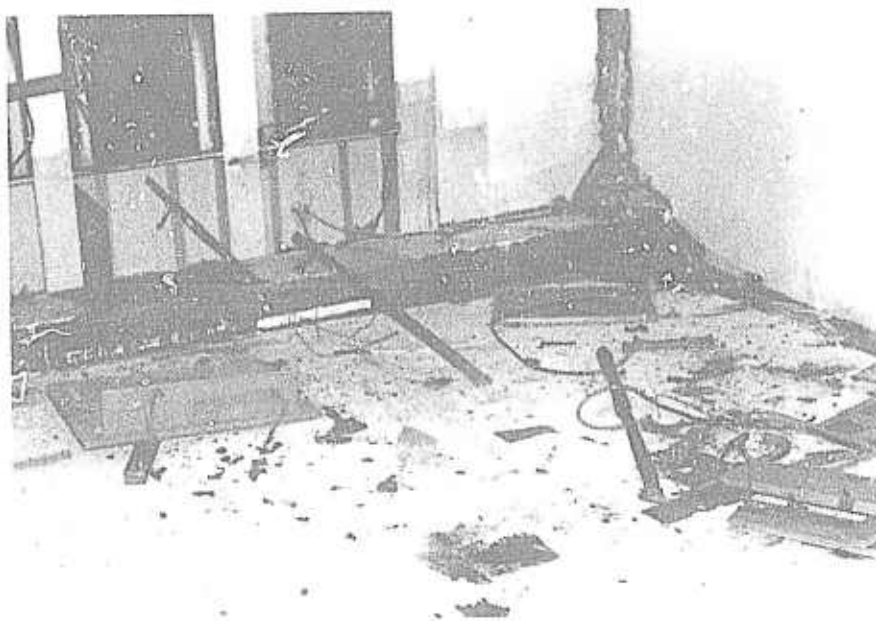
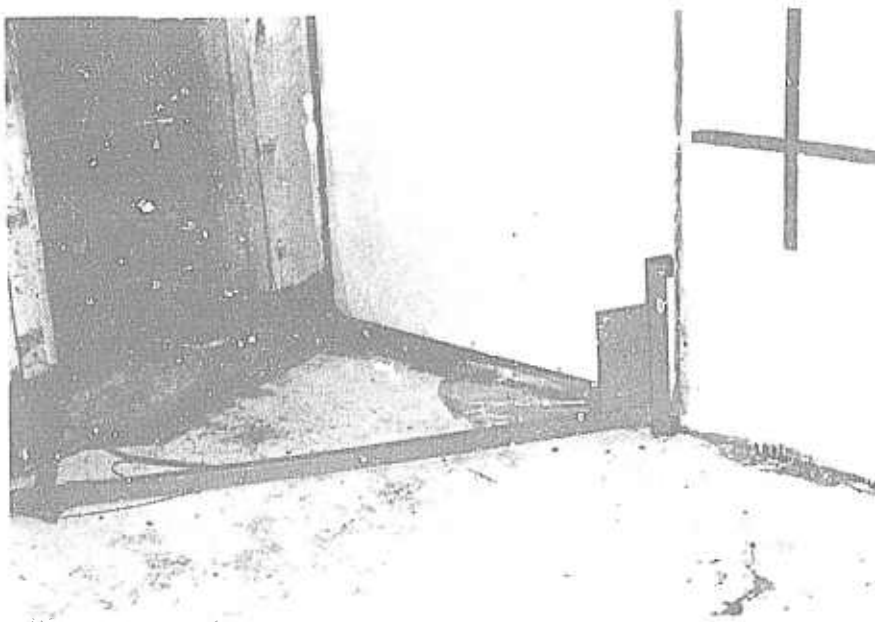
Fig. 3-10. Posttest Photographs, Test Number 11.

In all three tests, most of the cloth material was ejected from the room (Fig. 3-10) and scattered up to 100 ft from the doorway. In the first test, the clothes rack was dismantled and the tables tipped over. In the higher pressure tests, physical damage was great: tables and clothing racks were virtually destroyed, as can be seen in Fig. 3-10.

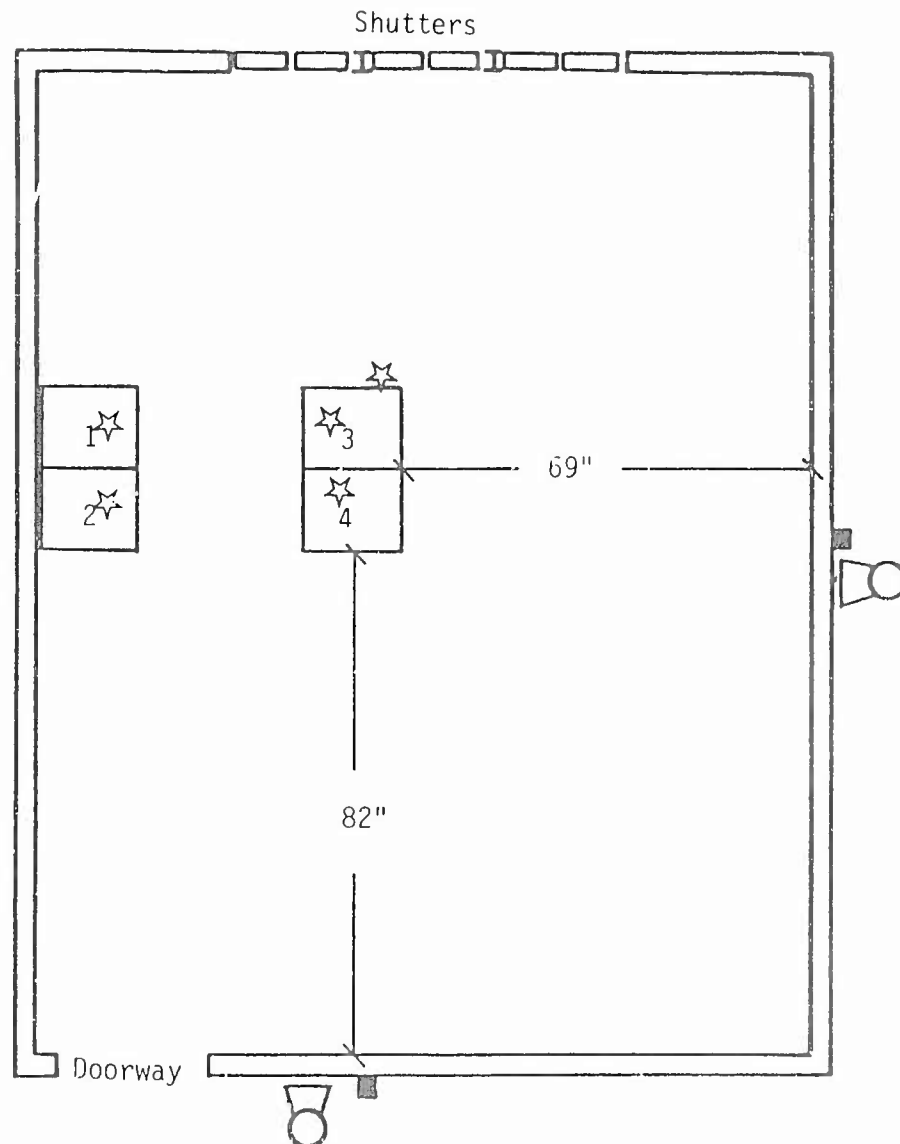
Fig. 3-11. Sketch of Test Geometry, Test Number 13

Five tests (Numbers 7, 13, 16, 18, and 20) were conducted in geometries generally similar to that shown in Fig. 3-11, with a stack of unweighted boxes in the center of the room and boxes weighted with lead blocks, along the side wall near the doorway. Both the central stack and a side box are shown in Fig. 3-12. In the last two tests, additional weighted boxes were placed near the other side wall and near the rear wall as well. In the first (low pressure) test, a small amount of crumpled paper was placed in all the boxes. In all the other tests, the top boxes in the central stack and those nearest the window contained large amounts of uncrumpled newspaper, and the boxes near the walls were entirely empty except for the lead weights.

- 1 & 2 - 17 x 13 x 13 in. cardboard boxes
 3 & 4 - 17 x 13 x 13 in. cardboard boxes (stacked three high)
 ☆ Ignition sources

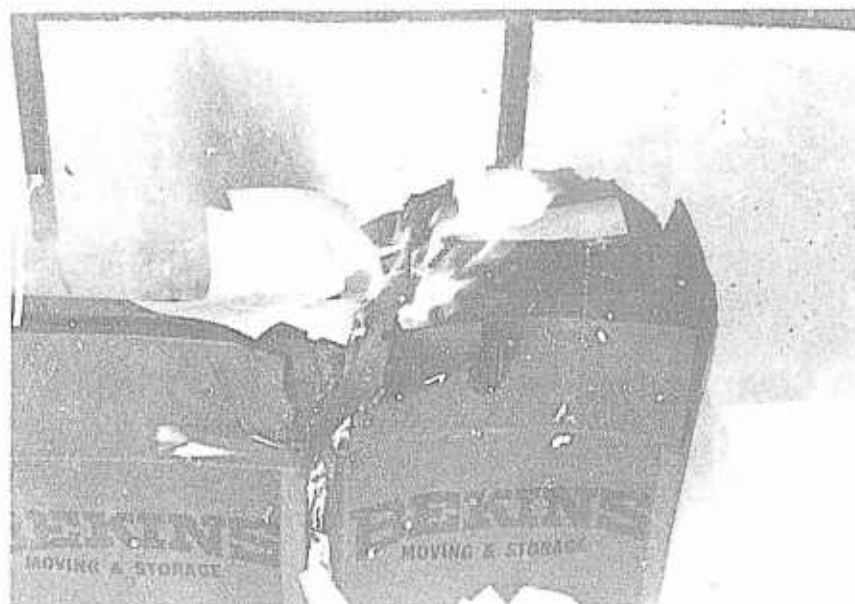
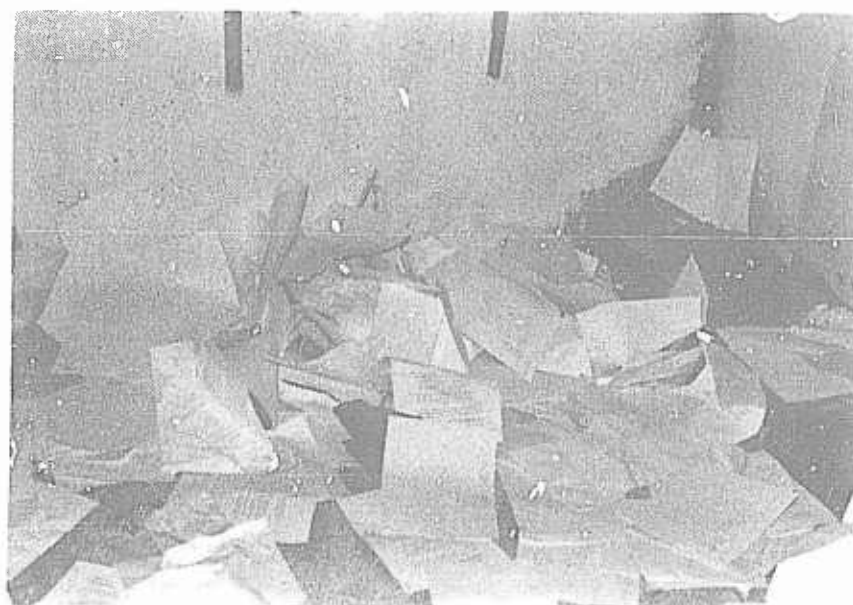
Fig. 3-13. Posttest Photographs, Test Number 16.

In all cases, fires in the central stack of boxes were extinguished and remained so. Much of the material from this stack was ejected from the room through the doorway although a fair amount was scattered about the room, and especially in the corners near the front (window) wall as shown in the lower photograph of Fig. 3-13.

In contrast, on two of the tests, (both of those at 4 psi) flames were observed in the weighted boxes along the side wall near the doorway immediately after the shot (within 30 seconds), as can be seen in the upper photograph of Fig. 3-13. On two of the other tests (Number 7 at 2 psi and Number 16 at 6 psi) flames were extinguished in these boxes, but they were still smouldering immediately after the test, and reignited within 10 minutes. On Test 16, the box near the other side wall was also smouldering immediately after the test, but the smouldering fire itself went out. The box near the rear wall on this test was ejected from the room, and all fires were extinguished.

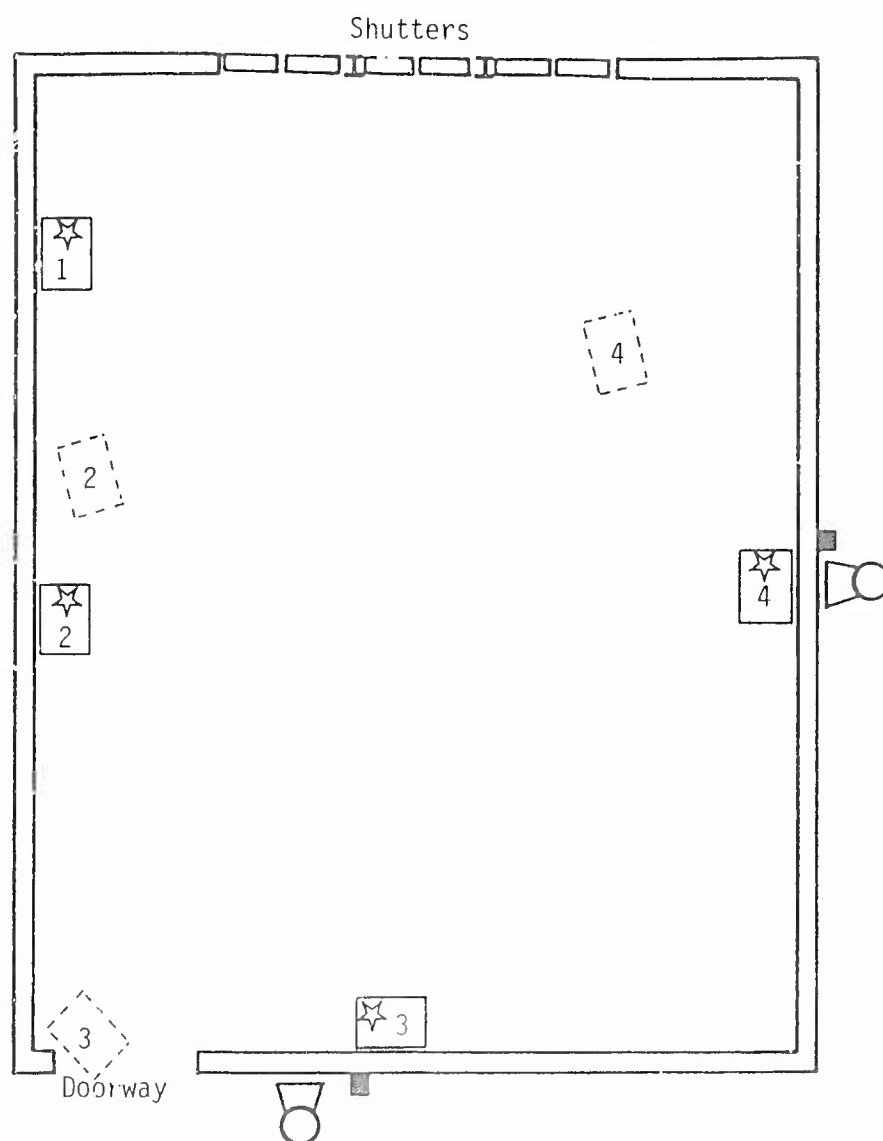
Fig. 3-14. Sketch of Test Geometry, Test Number 21

In these two tests, (19 and 21) run to acquire information on the importance of fuel location on the ability of blast to extinguish fires, paper was placed in four cages placed along the two side walls and the rear wall as is shown in Fig. 3-14 and the photographs of Fig. 3-15, and ignited before blast wave arrival. (A similar, but smaller, cage was placed near the doorway on Test 16, basically a warehouse geometry.)

1, 2, 3, and 4 - 8.5 x 12.5 x 8 in. wire cages containing paper (dotted lines indicate posttest locations)

On both tests, the material in the cage nearest to the window along the side wall burned completely, even though flow velocities through the window ranged up to about 550 ft/sec. On Test 19 the material in the other cage near the same wall also burned completely as shown in Fig. 3-16. In all other cases, fires in the cages were extinguished and the cages were moved (see Figs. 3-14 and 3-16), indicating the presence of strong eddies and counter currents.

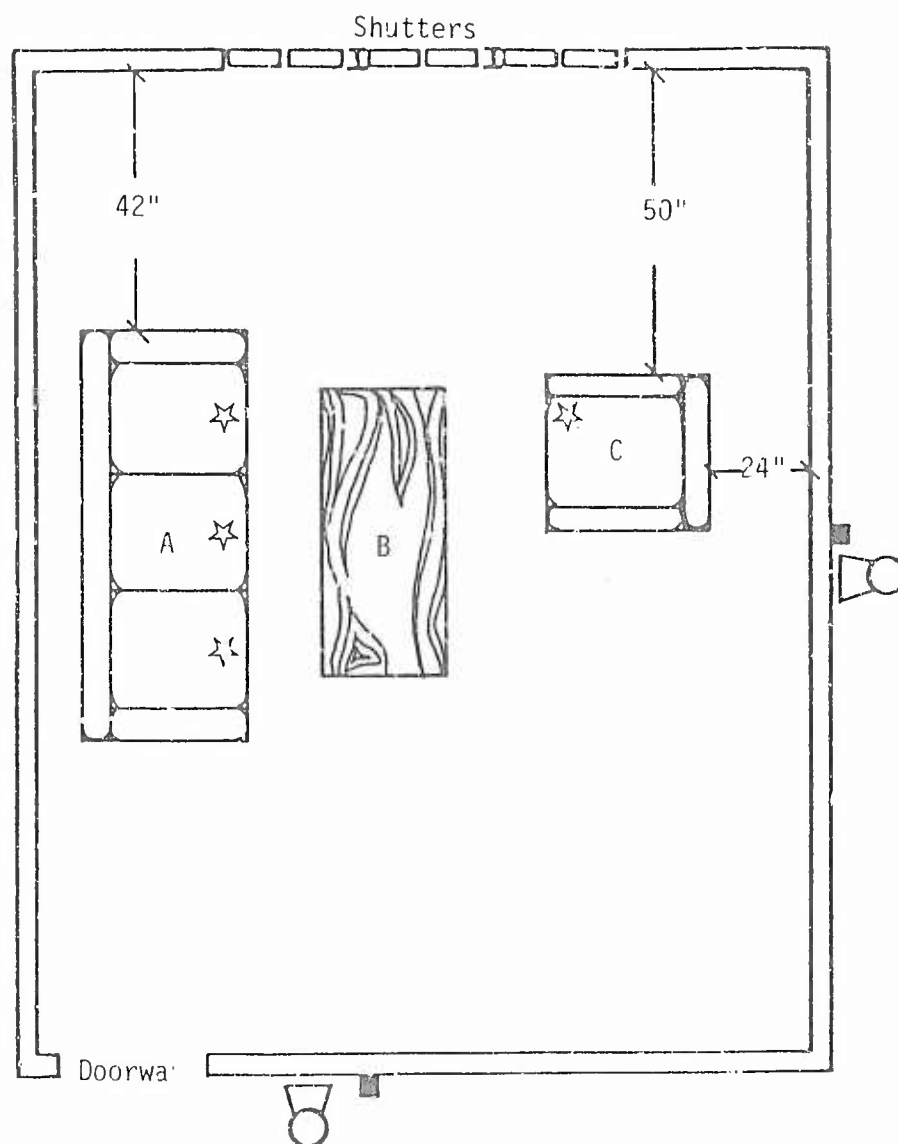
Fig. 3-17. Sketch of Test Geometry, Test Number 10

Three tests (Numbers 8 through 10) were attempted with living room geometries like those shown in Fig. 3-17, but only one (Number 10) was successful. (In Test 8, with a compression chamber pressure of about 2 psi, fires were not ignited; in Test 9 with a compression chamber pressure of about 4 psi, the shutters did not open, and all materials in the room, except the coffee table burned up.) The test rooms all had a wood frame couch with plastic covered cushions, a wooden coffee table, and a wood frame chair with plastic cushions. A pretest photograph (from Test 8) is shown in Fig. 3-18.

- A - 69 x 28 in. wood frame sofa with plastic cushions
- B - 48 x 18 in. wood coffee table
- C - 30 x 25 in. wood frame arm chair with plastic cushions
- ☆ Ignition sources

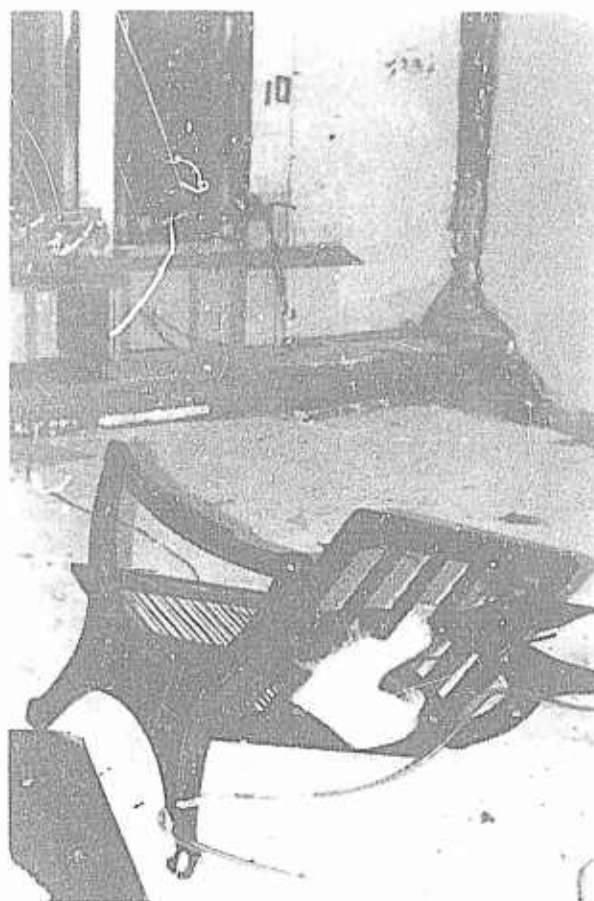
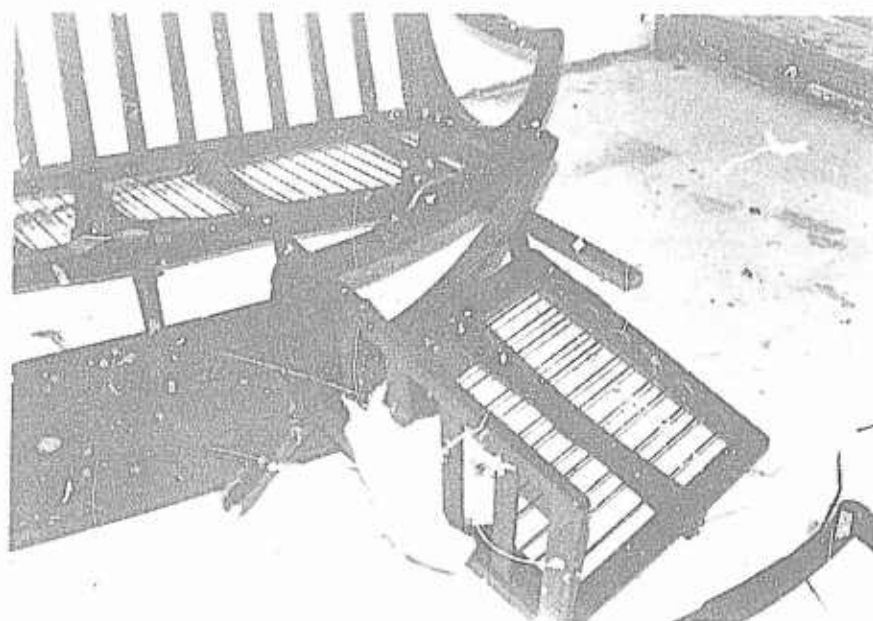
Fig. 3-19. Posttest Photographs, Test Number 10.

All fires were blown out and stayed out. As can be seen in Fig. 3-19, both the chair and table were broken. Most of the cushions were blown outside the room, and the cover and cushioning material were separated on those that were most severely burned.

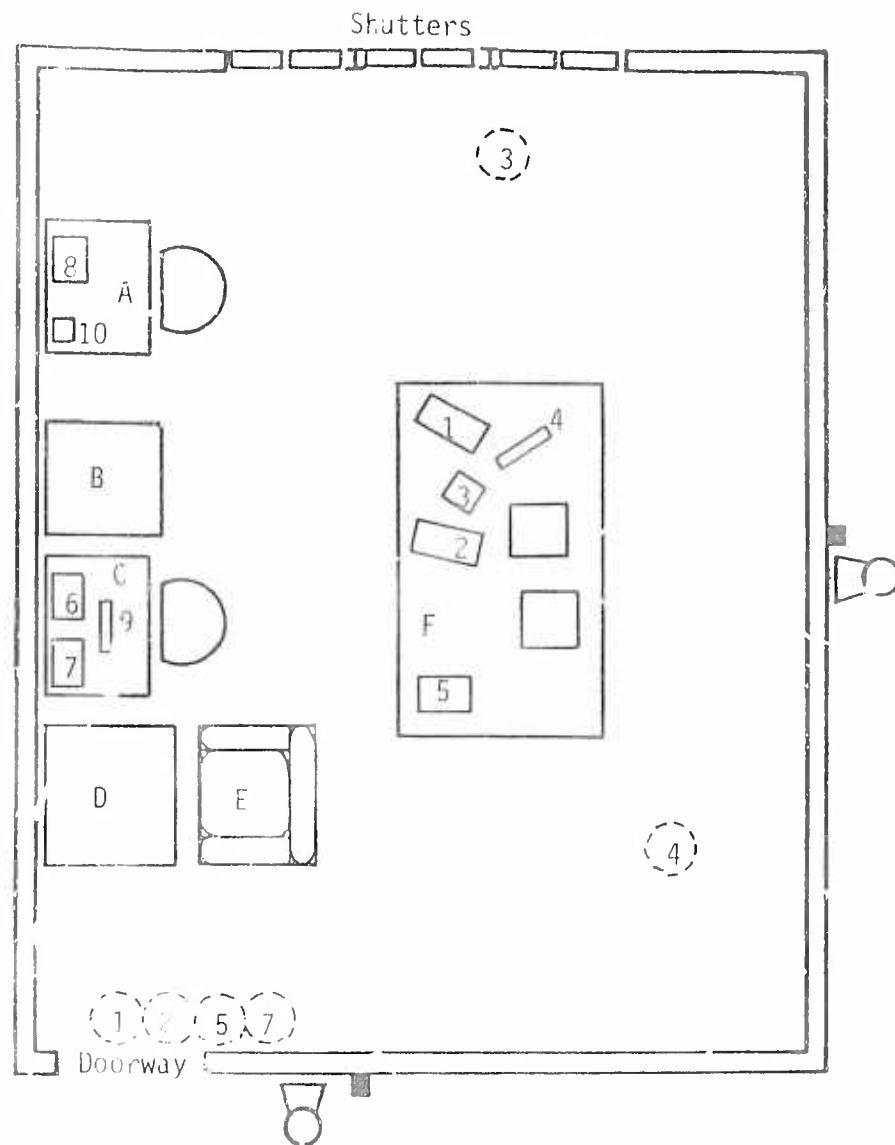
Fig. 3-20. Sketch of Test Geometry, Test Number 14

In these two tests (Numbers 14 and 17) equipment and other materials typical of those in EOC's were placed in the LDFF test room. One of the arrangements adopted is sketched in Fig. 3-20, the other is shown in the photographs of Fig. 3-21. Compression chamber pressure was 4 psi in both cases, but three shutters were opened on Test 14, and two on Test 17. Thus flow velocities through the window were about 450 ft/sec and 550 ft/sec respectively.

A & C - 23 x 18 n. school desk

B - 20 x 20 x 84 in. relay rack

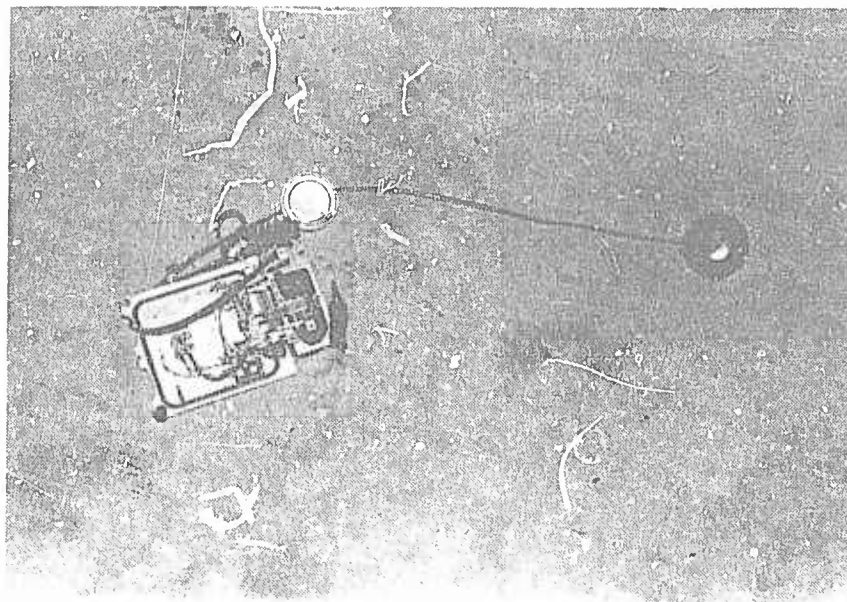
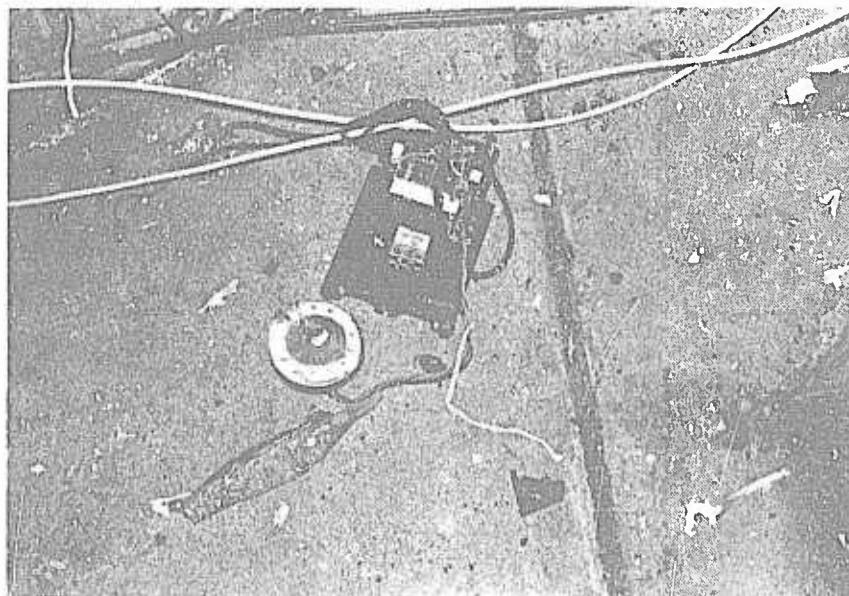
Fig. 3-22. Posttest Photographs, Test Number 17.

While a few items of equipment located along the side wall near the window were undamaged after the first test, all equipment sustained some damage as a result of the second test (only one item was still operable) and much was ejected through the doorway as shown in Fig. 3-22. Refer to the individual test reports for additional information on particular items of equipment.

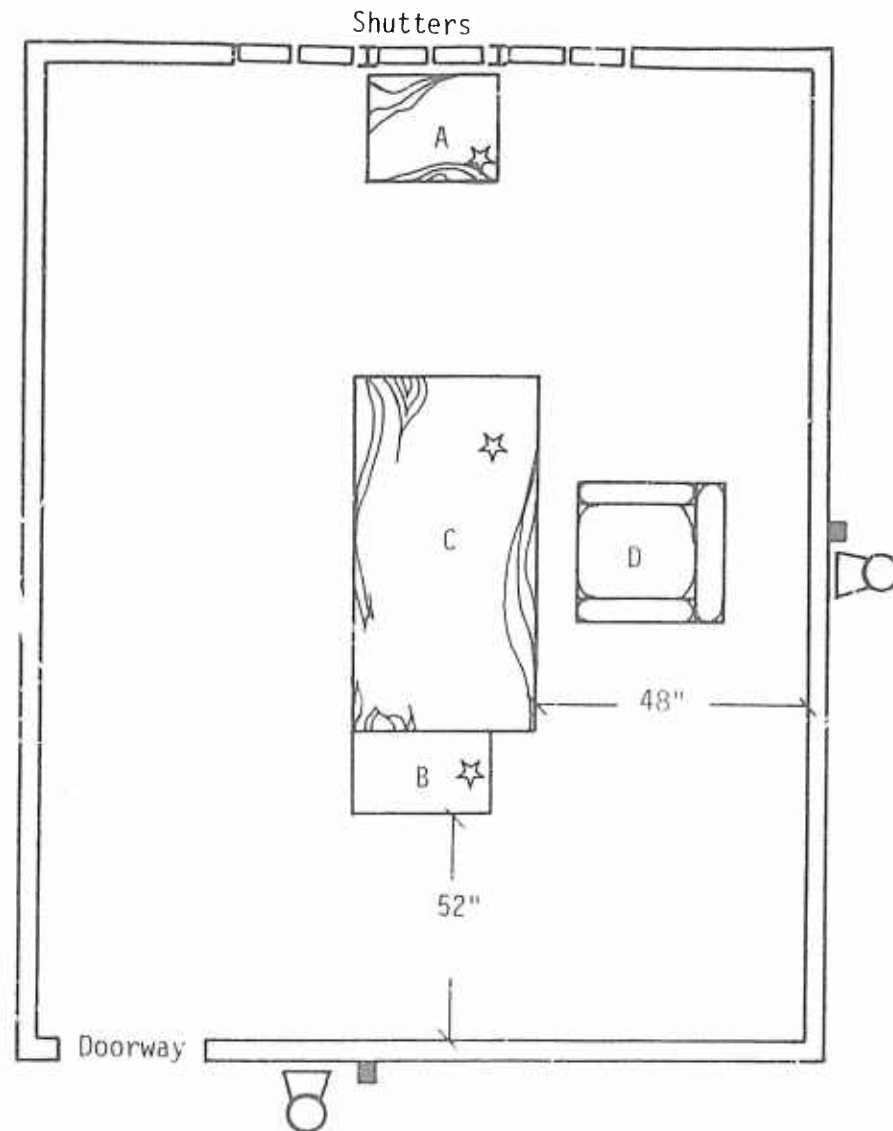
Fig. 1-1. Sketch of Test Geometry, Test Number 1

The simulated office consisted of a desk, chair and four drawer file cabinet, all located in the center of the room and a book table located directly in front of the shutters. Papers were placed on the desk and in the top and bottom drawers of the file cabinet which were left open. Books were placed on the book table.

- A - 24 x 22 in. table with books
- B - 26 x 14 in. 4 drawer steel file cabinet (top and bottom drawer open containing paper)
- C - 34 x 60 in. wood desk (paper scattered on top)
- D - chair with steel frame and plastic cushions
- ☆ Ignition sources

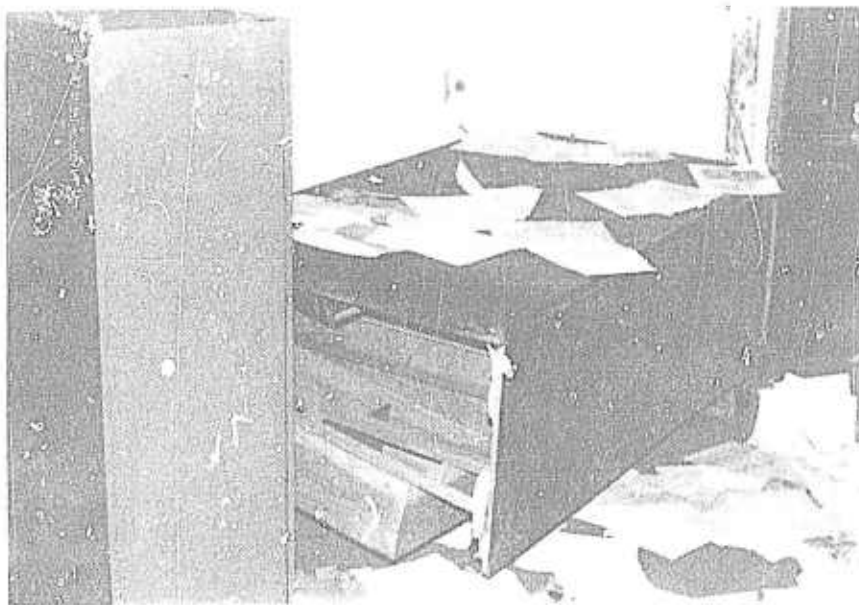
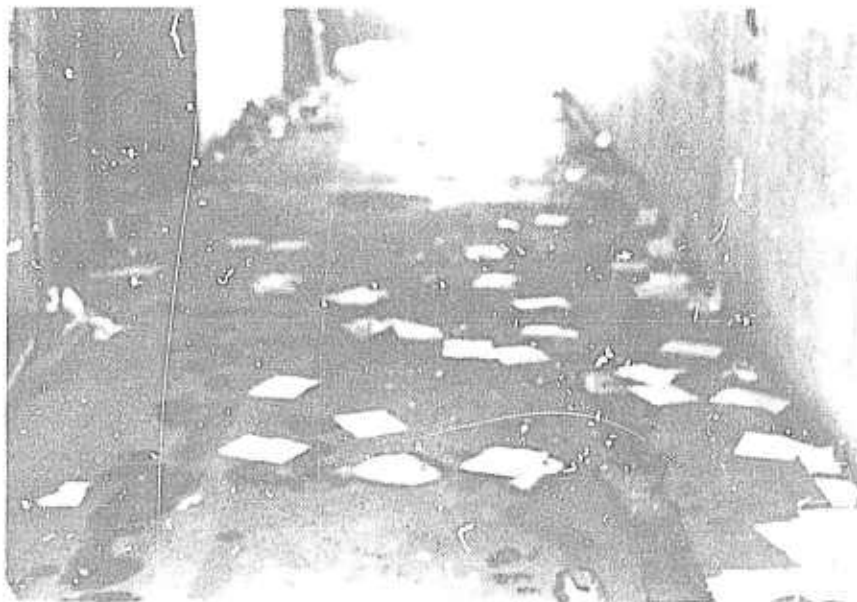
Fig. 1-4. Posttest Photographs, Test Number 1

The blast put out all the fires, moved the file cabinet and desk (slightly damaging the desk) and scattering papers around the room and in the outside hallway.

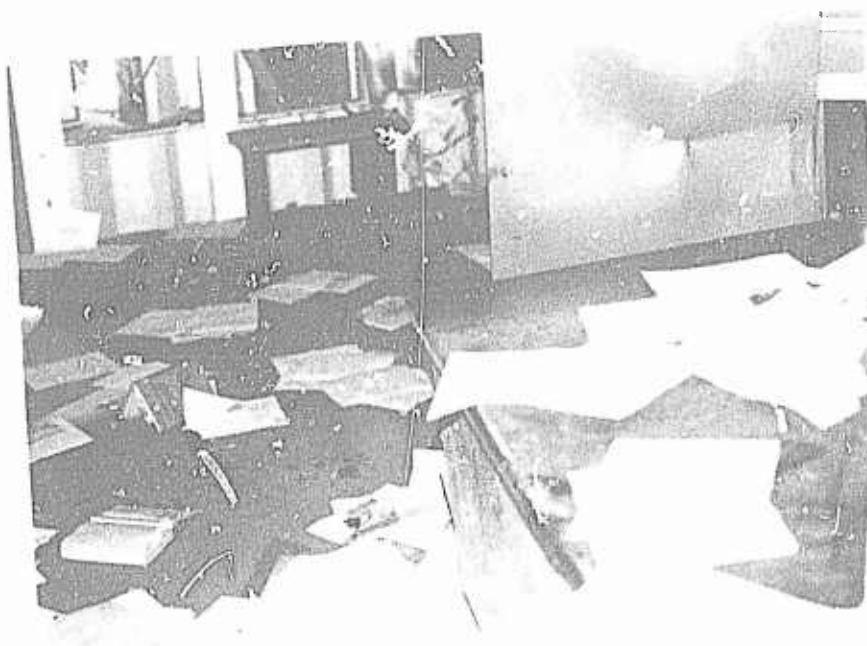
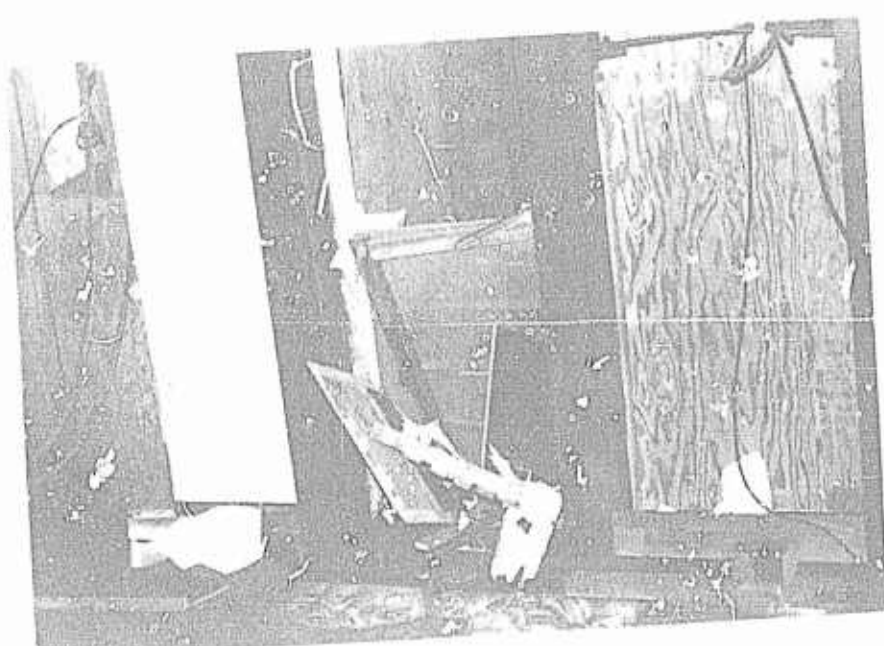
Fig. 2-2. Posttest Photographs, Test Number 2

This test was essentially a repeat of test one at a higher pressure. (See Fig. 1-1). The blast put out all of the fires and did considerably more damage. The desk was broken up and was driven part way out the door. The file cabinet was knocked over and ended up on top of the desk. See the posttest photographs Figs. 2-3 and 2-4.

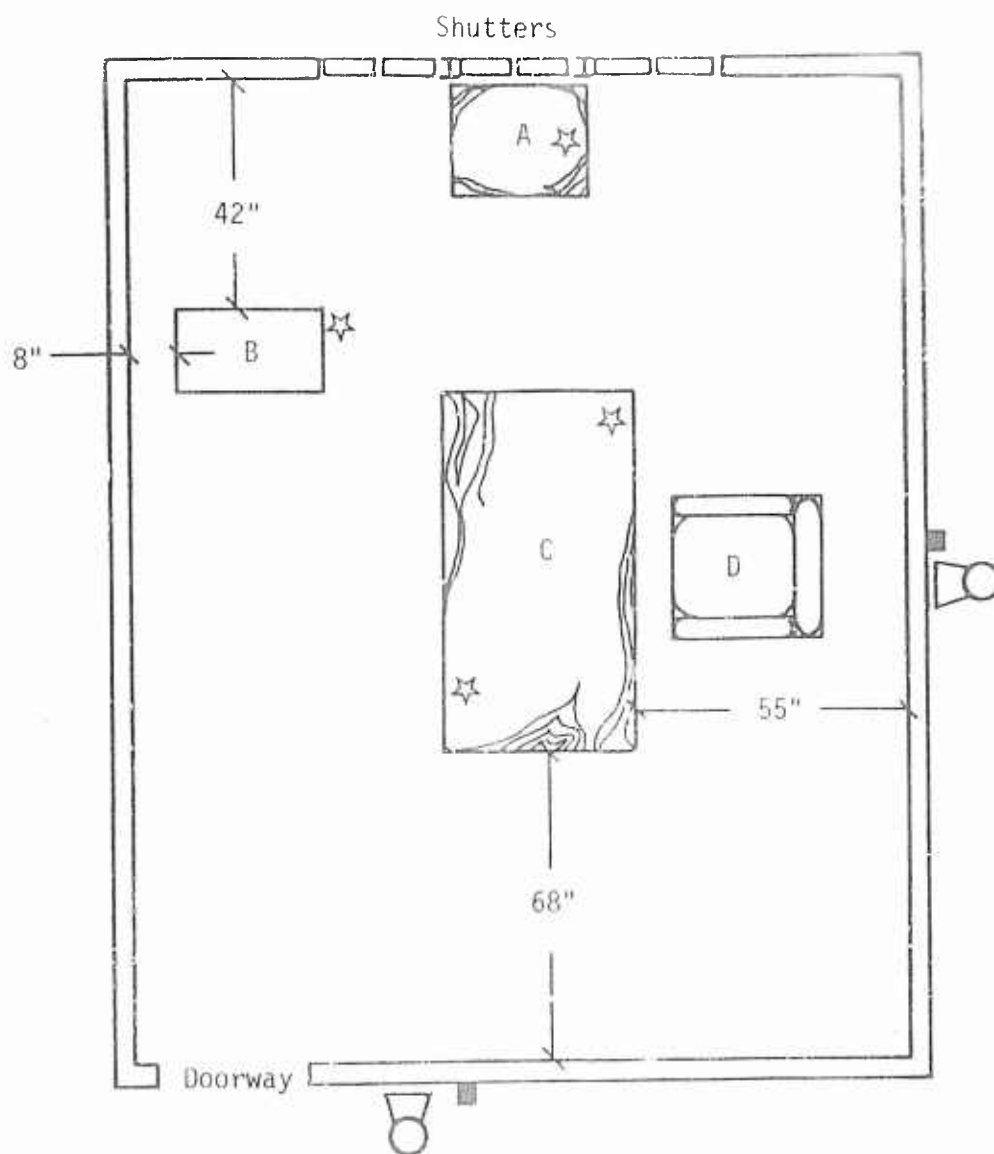
Fig. 3-1. Sketch of Test Geometry, Test Number 3

The simulated office consisted of a desk and chair in the center of the room, a four drawer file cabinet with the top and bottom drawers open, and a book table directly in front of the shutter opening (See sketch in Fig. 3-1). Paper was placed on the desk and in the drawers of the file cabinet, and books were placed on the table. Each location had an ignition source. See photographs in Fig. 3-2A and B.

- A - 24 x 22 in. table with books
- B - 26 x 14 in. four drawer file cabinet
- C - 34 x 60 in. wood desk
- D - chair with steel frame and plastic cushions
- ☆ Ignition sources

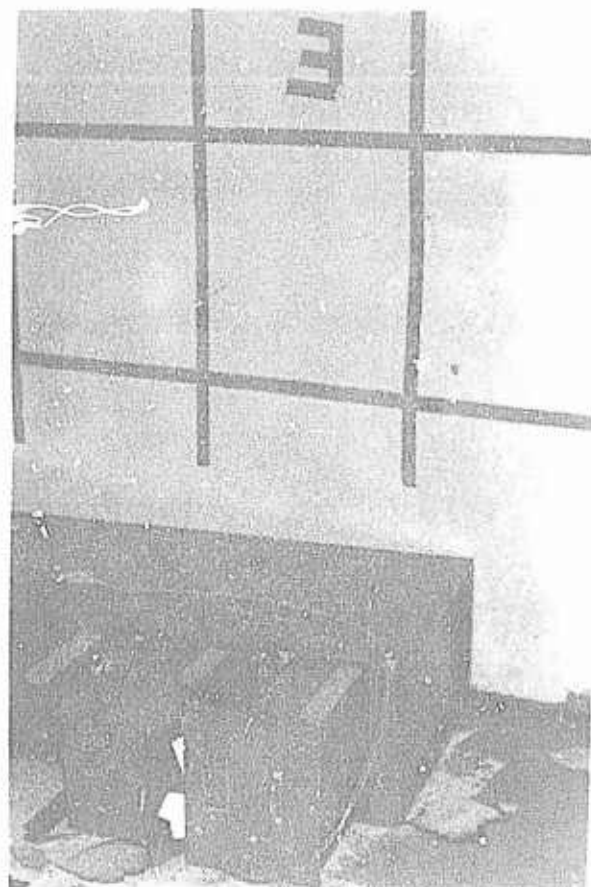
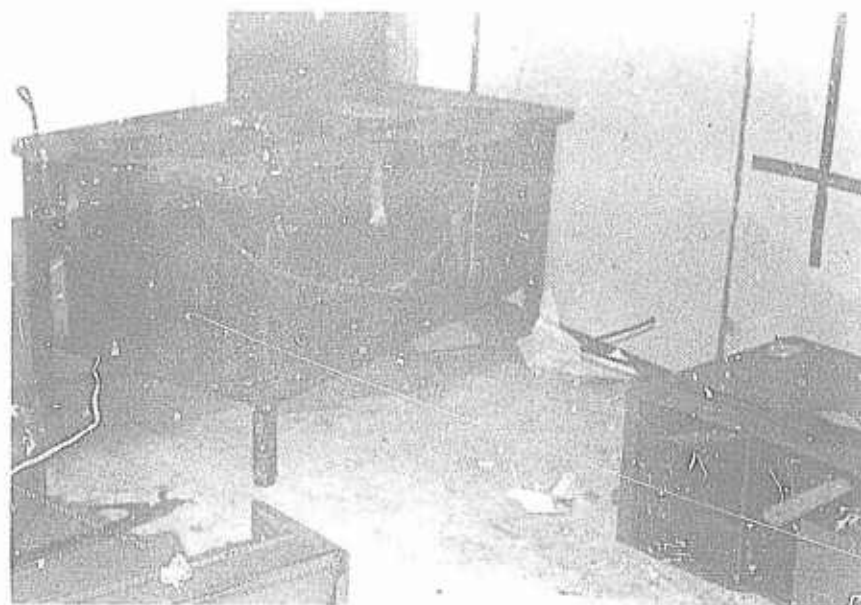
Fig. 3-3. Posttest Photographs, Test Number 3.

The blast put out all fires, pushed the desk into the doorway, broke the chair and pushed it against the back wall and tipped over the file cabinet spilling the contents on the floor. See posttest photographs Figs. 3-3 and 3-4.

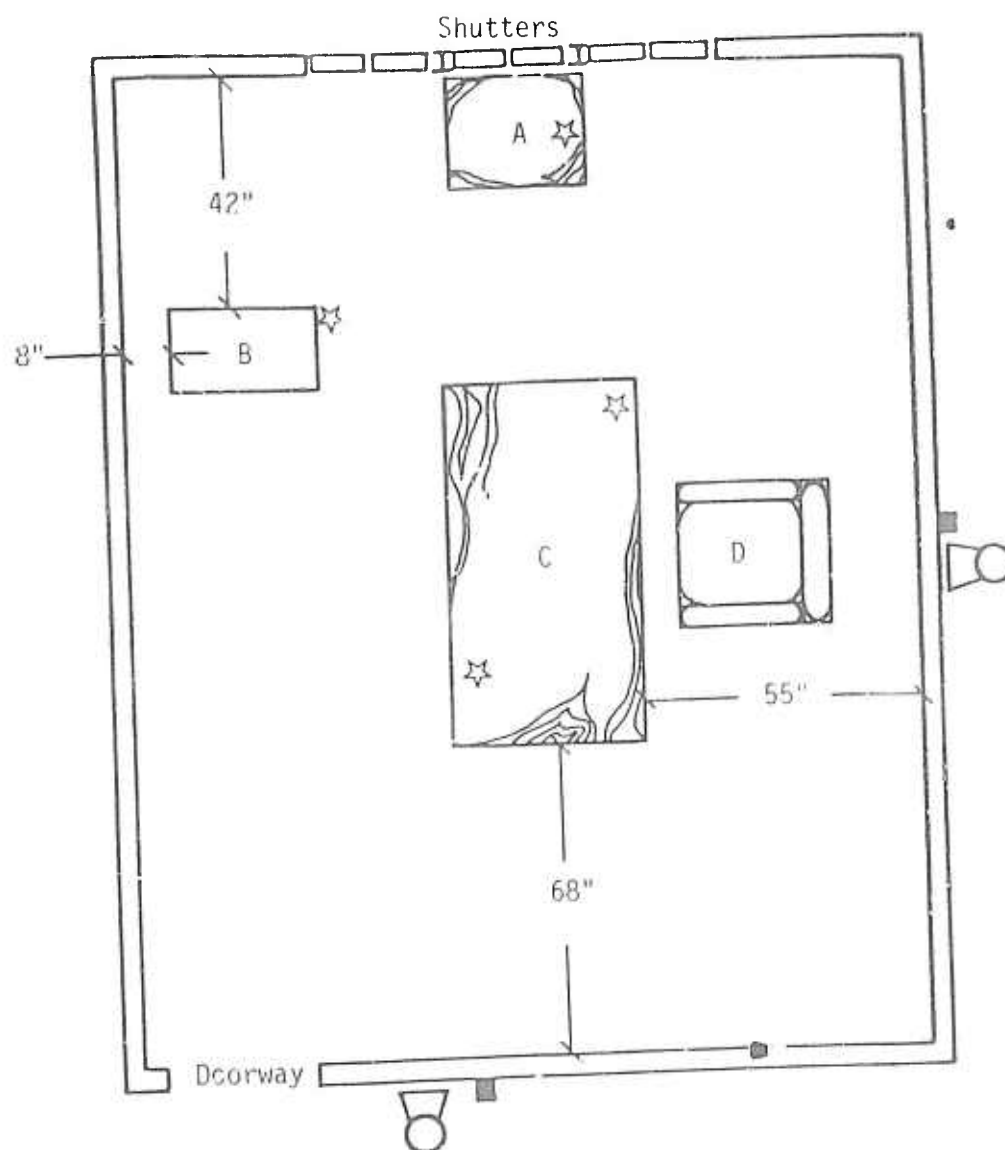
Fig. 4-1. Sketch of Test Geometry, Test Number 4

The simulated office consisted of a desk and chair in the center of the test room, a four drawer file cabinet with the top and bottom drawer open, and a book table directly in front of the shutter opening. (See sketch in Fig. 4-1). Paper was placed on the desk and in the file cabinet and books were placed on the table. There was an ignition source for each of the above locations. See pretest photographs in Figs. 4-2 and 4-3.

- A - 24 x 22 in. table with books
- B - 20 x 14 in. four drawer file cabinet
- C - 34 x 60 in. wood desk
- D - chair with steel frame and plastic cushions
- ☆ Ignition sources

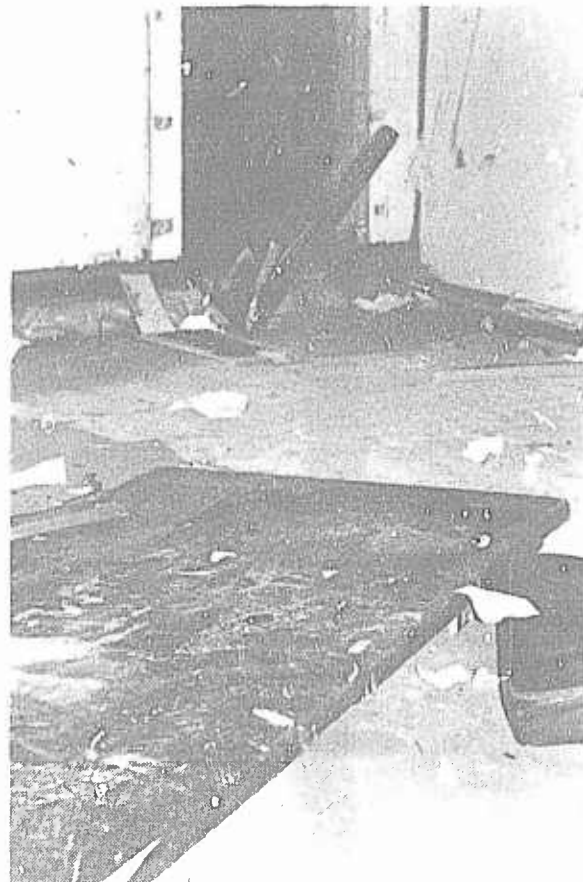
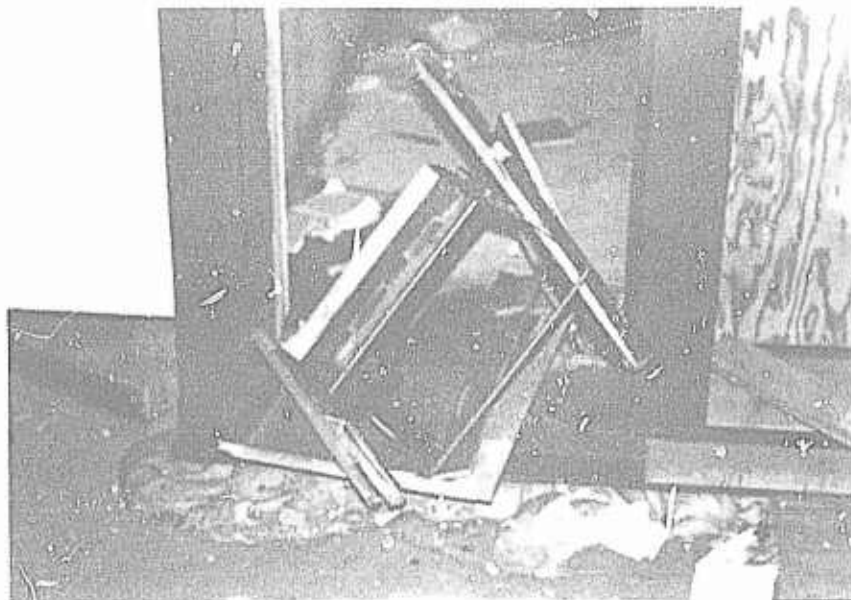
Fig. 4-4. Posttest Photographs, Test Number 4

The blast wave put out all fires and severely damaged the desk, leaving the top on the floor and pushing the remainder part way through the doorway (See photographs Fig. 4-4). The chair was also severely damaged (See Fig. 4-6B), and numerous papers and parts of the desk were scattered along the corridor outside the test room.

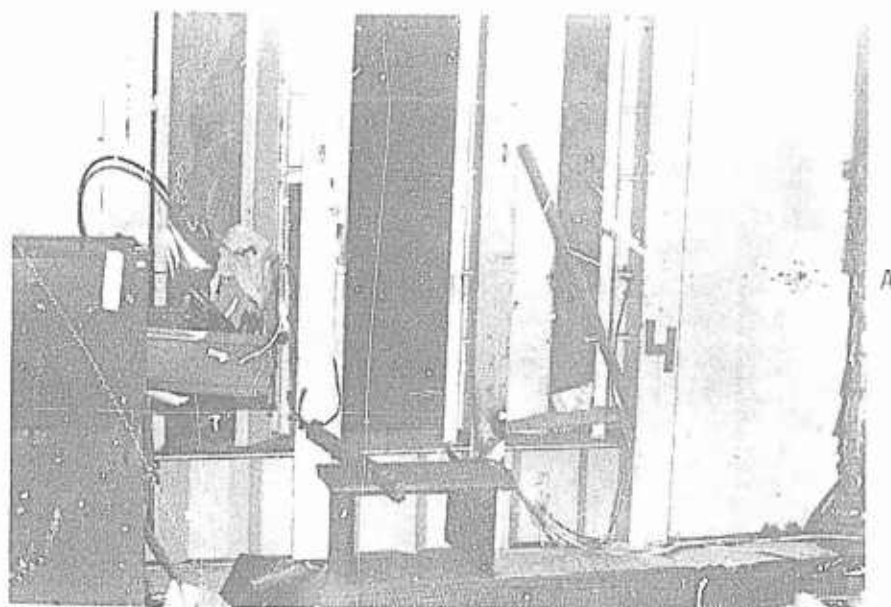
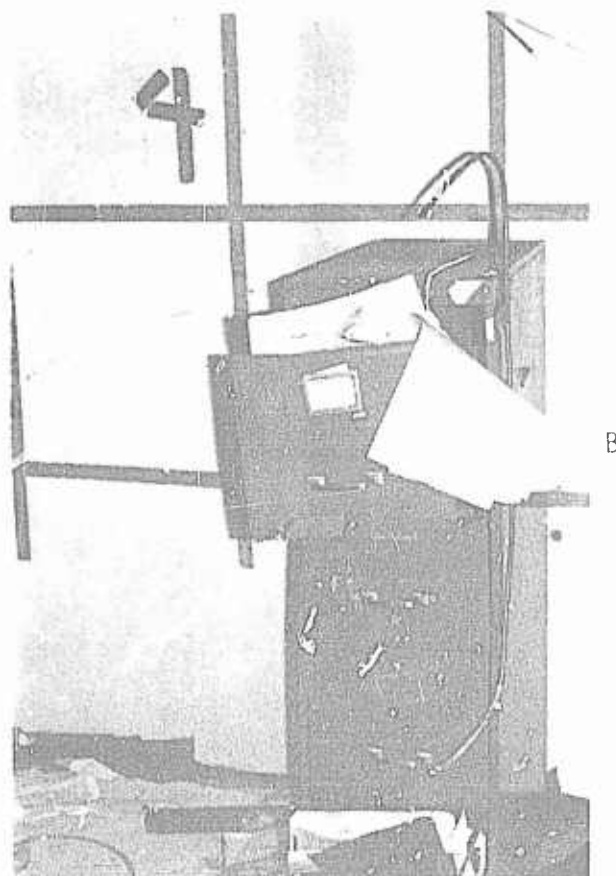
Fig. 4-5. Posttest Photographs, Test Number 4.

* A 7" opening had been planned, but as Fig. 4-5A shows, two shutters opened.
